CT156102 Harvard II - Epilogue - Flight Safety Investigation Report

Report / January 24, 2014 / Project number: CT156102 - A Cat

CANADIAN FORCES FLIGHT SAFETY INVESTIGATION REPORT (FSIR)

FILE NUMBER: 1010-CT156102 (DFS 2-2-2)

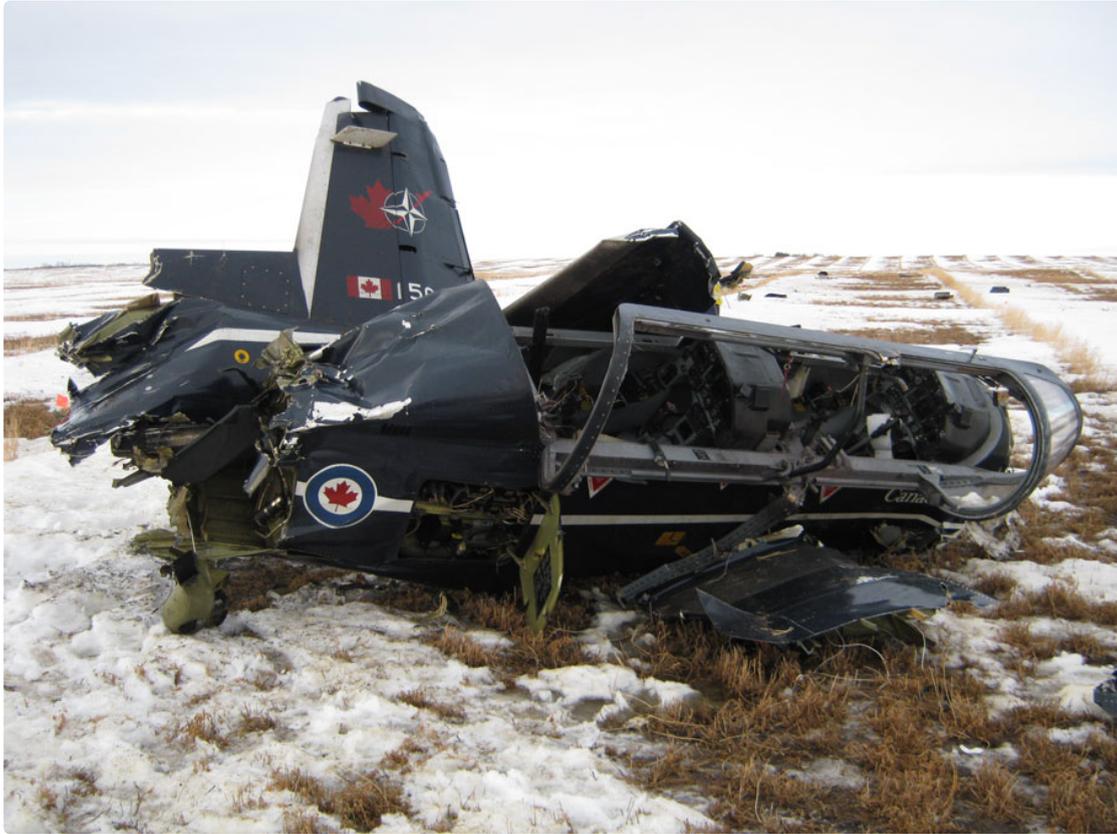
A Harvard II chase aircraft joined up to visually inspect and photograph the damage. The photographs were returned to base which allowed maintenance personnel to confirm that the left main landing gear (LMLG) brace had become detached from the strut. Meanwhile, a second Harvard II chase aircraft joined up with the accident aircraft. Several attempts were made by the accident aircraft to attain a symmetrical gear up configuration for a possible belly landing; however, a symmetrical configuration was not achieved.
