EC225 Bevel Wheel Vertical Shaft - Lessons Learnt

*Andrew Dettl – Aberdeen Customer Support Director and Site Manager
4 June 2014*

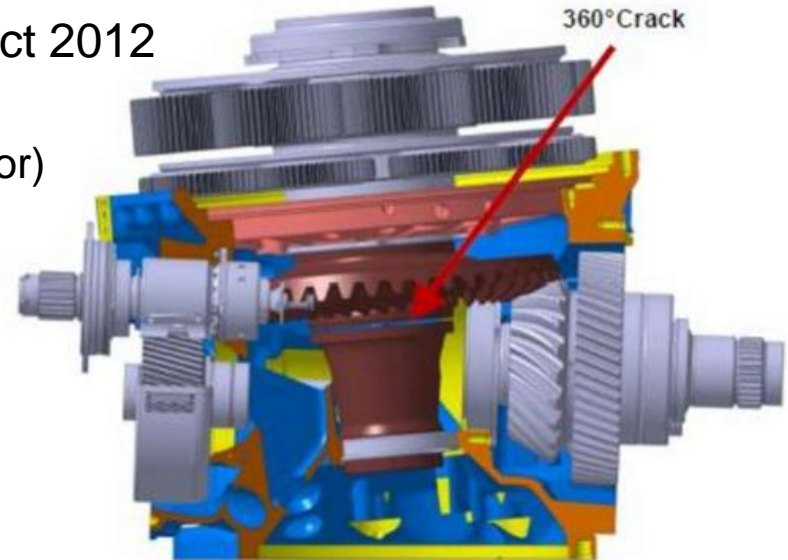
Two EC225 controlled ditchings in May and Oct 2012 due to two separate problems:

- failure of Bevel Wheel Vertical Shaft (causal factor)
- indication of EMLUB failure (contributing factor)

Detailed (~6 month) investigation of 149 potential root causes revealed the cause to be a combination of:

- **Active Corrosion** due to trapped moisture
- **Residual Stress** due to manufacturing process
- **Stress Concentration** (Hot Spots) due to shaft geometry (shape)

Mid 2013 - Short Term Preventive and Protective Safety Measures implemented to address the root causes and minimise the likelihood or consequence of failure:

- suspect batches (non-conforming hole/chamfer) removed from service
- manual and automatic (oil jet) cleaning
- US NDI – detects a crack on the ground
- MOD45 Monitoring – detects a crack in-flight

Mid 2014 - Permanent Redesign implemented to eliminate all root causes

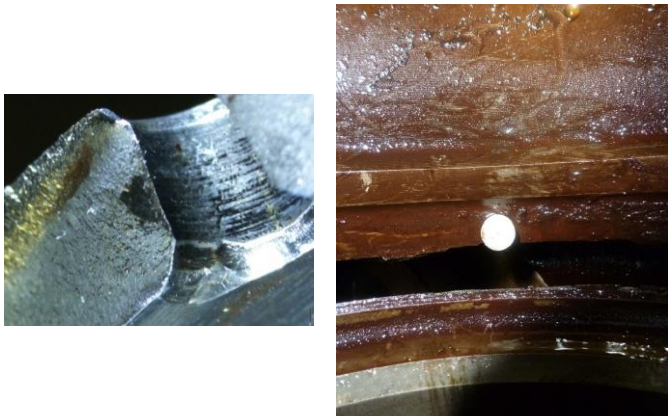
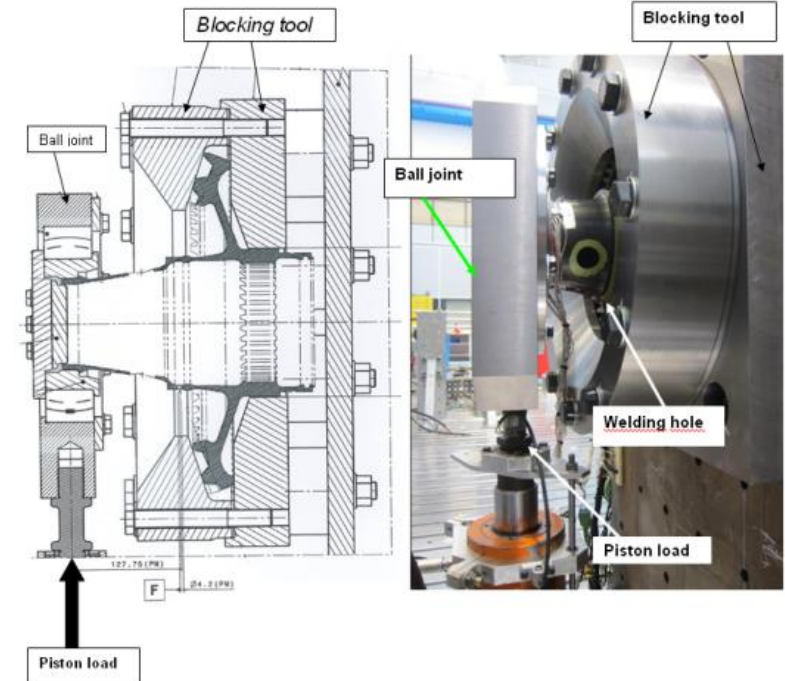
- Conditions to generate an initiating corrosion pit (outside of the weld plug hole) not imagined before the 2nd ditching
- ‘Aberdeen factor’ needed to be fully investigated
- Positive verification if potential root causes did or didn’t contribute to the failure
- Novel experiments
- Replicating the phenomena
