NATIONAL TRANSPORTATION SAFETY BOARD

Group Chairman's Factual Report

OPERATIONAL FACTORS

DCA13FA131

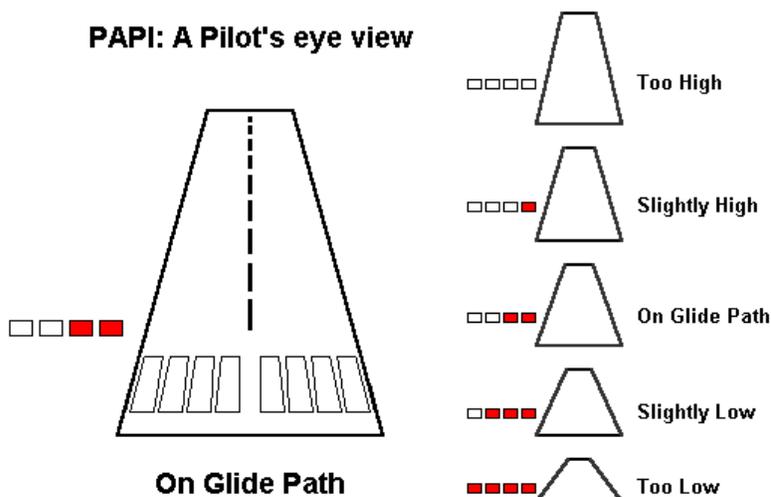
and two red lights were visible during the approach to the runway. Three or four white lights would indicate the airplane was high on the glidepath, while three or four red lights would indicate the airplane was low. The graphic below illustrates the lighting for high, low and on visual approach path, but at KLGA, the PAPI lights were located to the right side of the runway while on approach. However, a note on the Jeppesen approach plate (11-1) for ILS Runway 4, stated, *VGSI [PAPI] and ILS glidepath not coincident*.

Graphic 3: PAPI: A Pilot's eye view
Note: The KLGA Rwy 4 PAPI was located on the right side of the runway during the approach
